Happy Valley Environmental Review

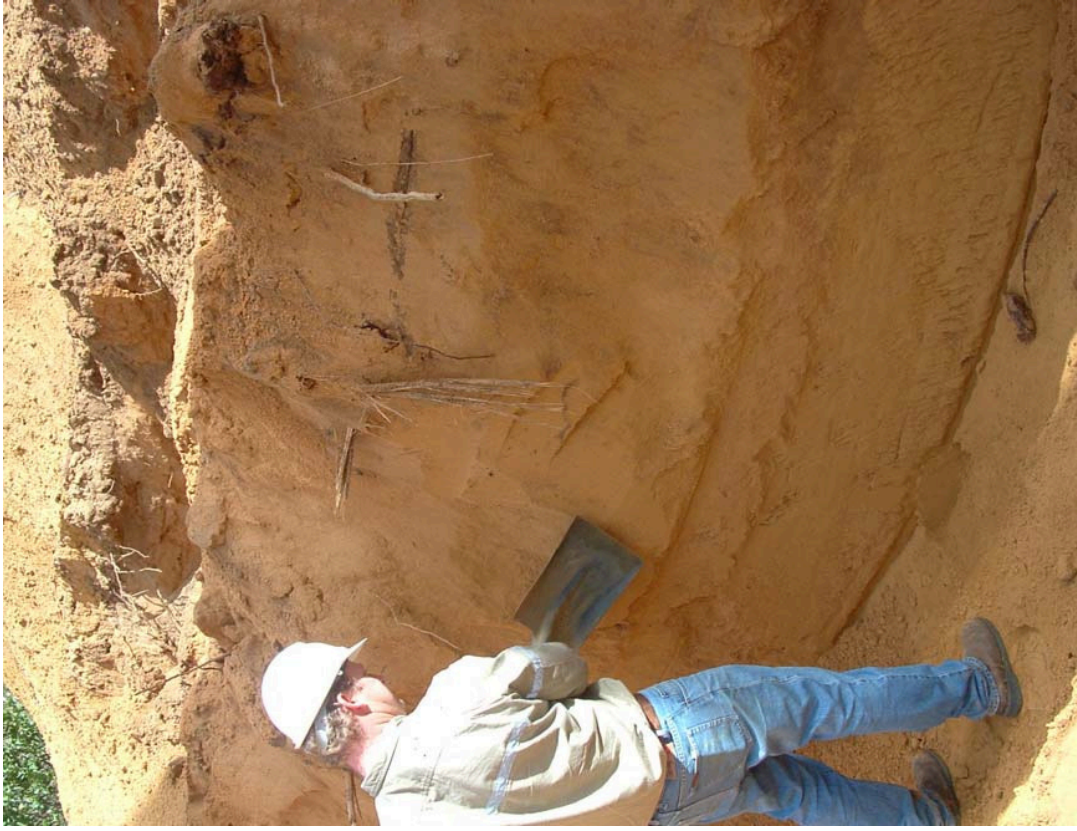
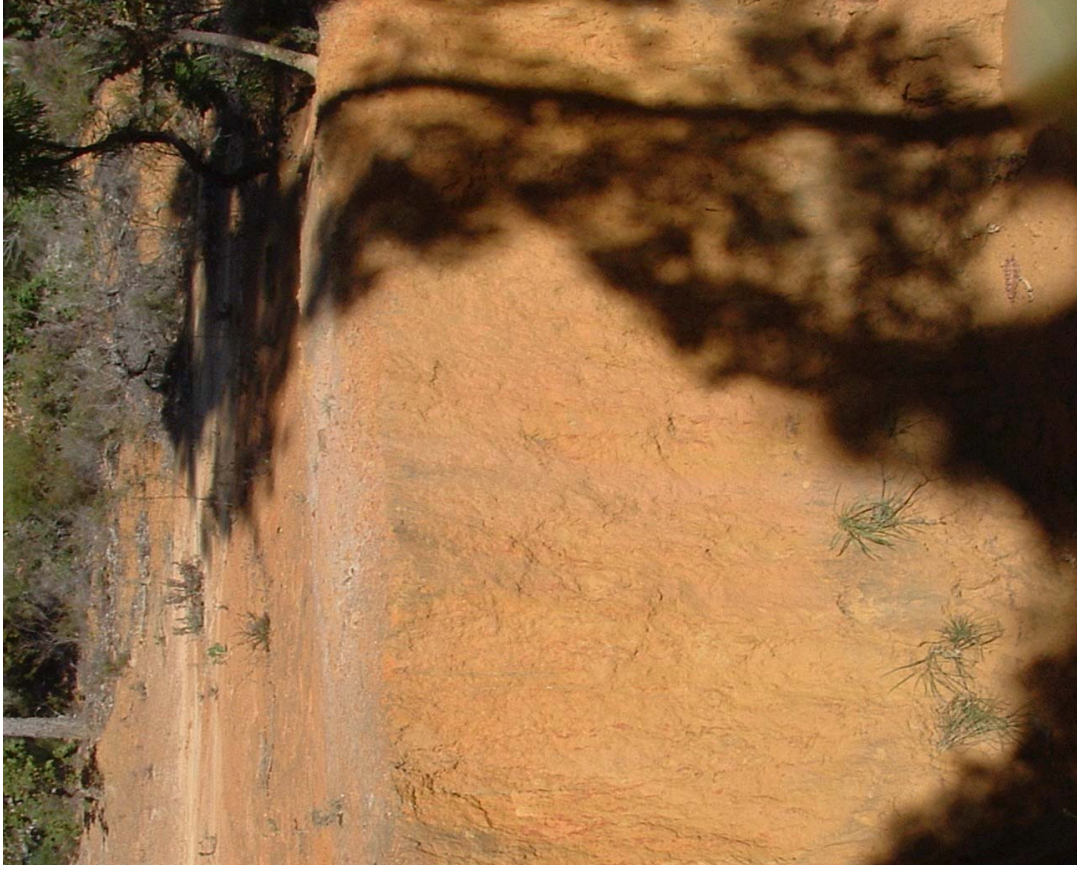
FIGURE 4-7

YELLOW SAND UNIT: ABOVE LATERITE (LEFT) AND BELOW LATERITE (RIGHT)

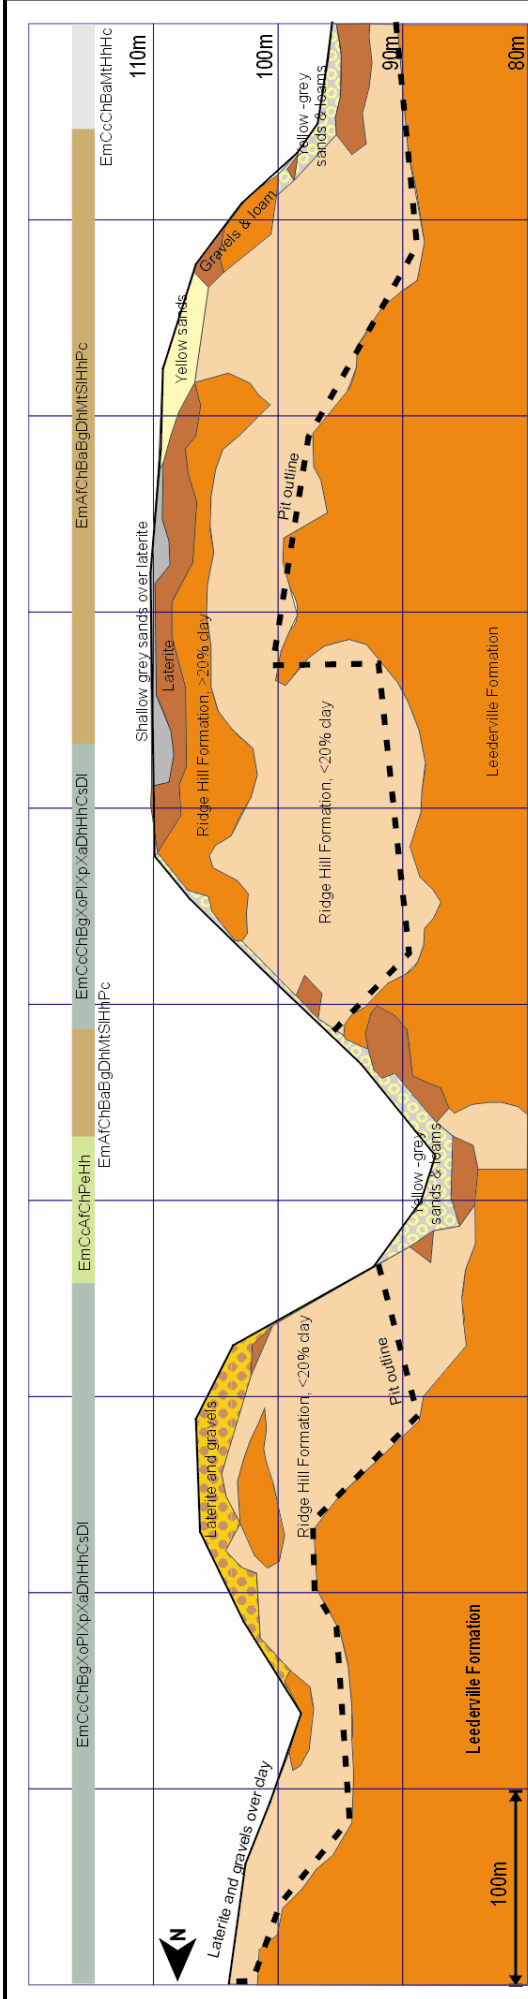
FIGURE 4-8

Happy Valley North 3800mE drill line (view east)

INTERPOLATED CROSS-SECTIONS OF THE HAPPY VALLEY NORTH OREBODY WITH VEG UNITS

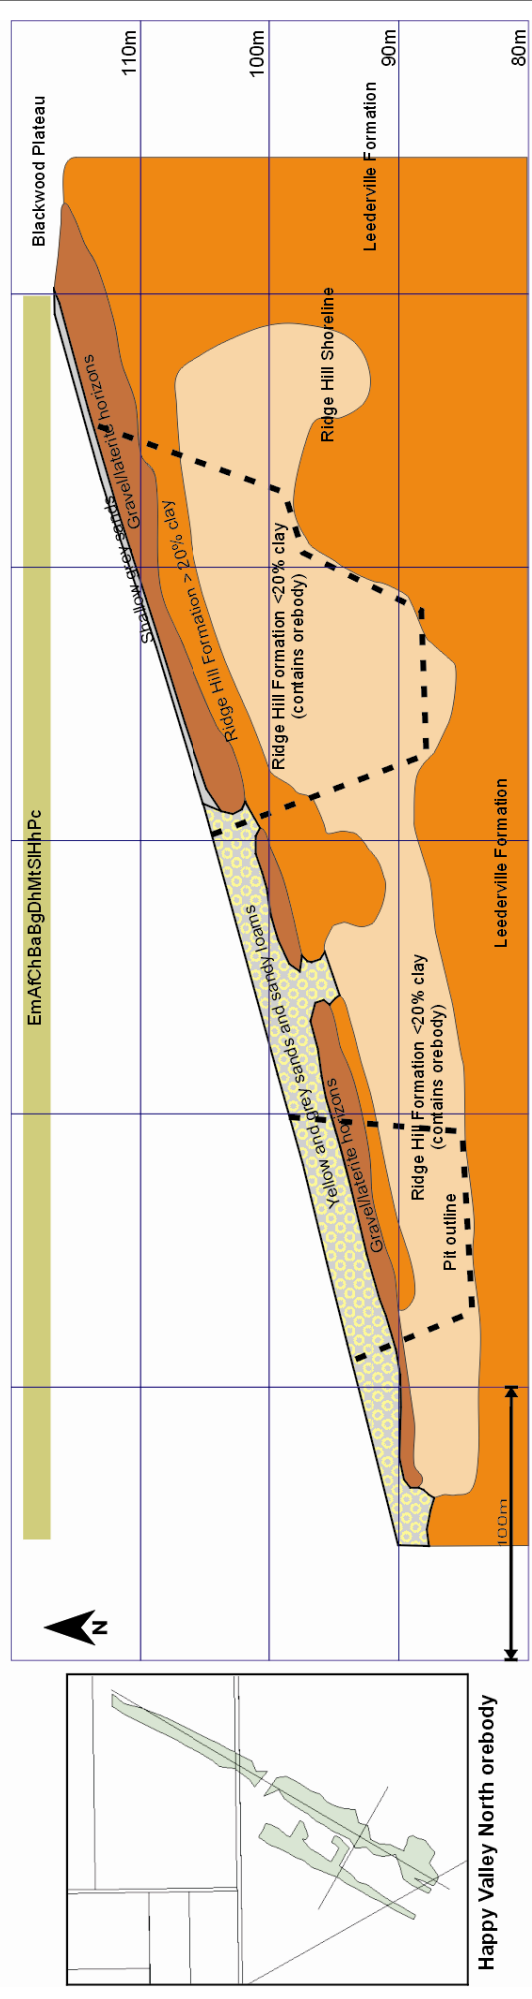
Happy Valley North 8005mN drill line (view north)

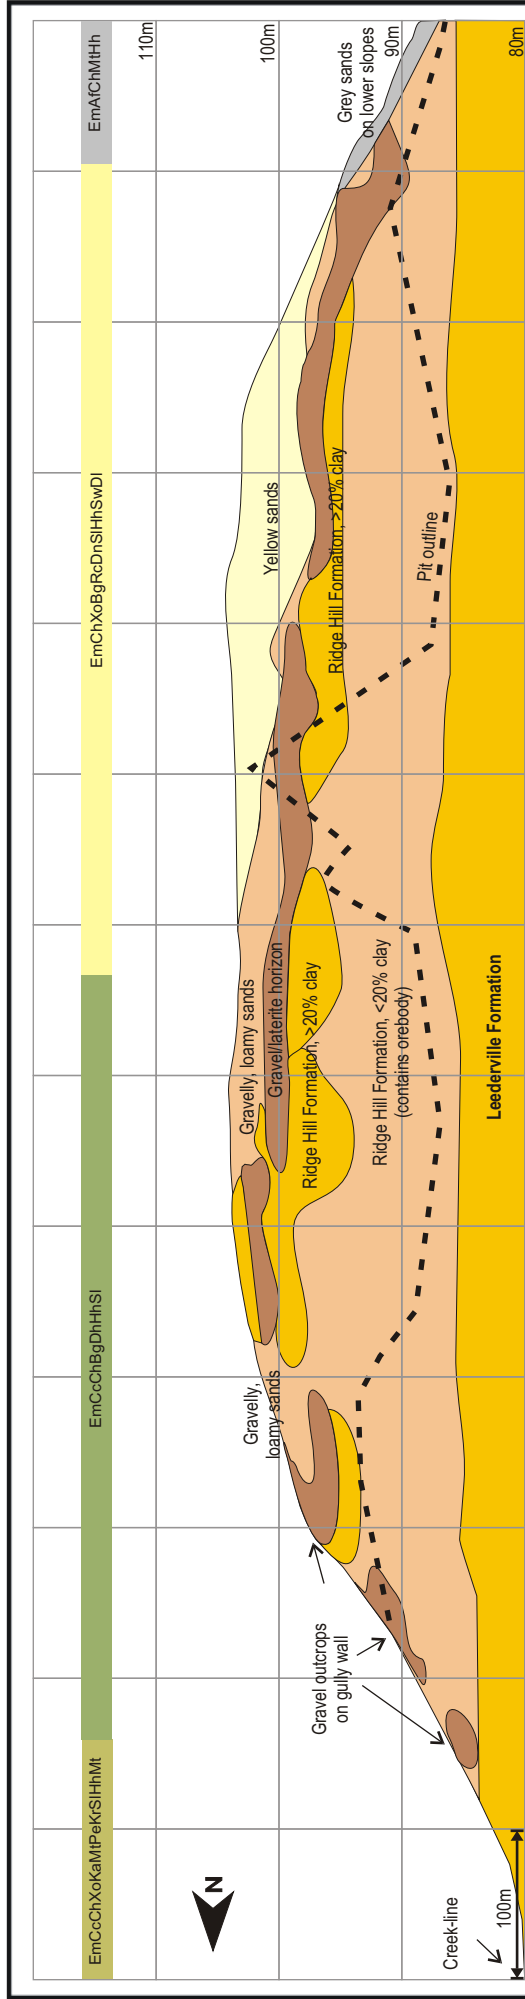
FIGURE 4-9

Happy Valley South 37500mE drill line (view east)

INTERPOLATED CROSS-SECTIONS OF THE HAPPY VALLEY SOUTH OREBODY WITH VEG UNITS

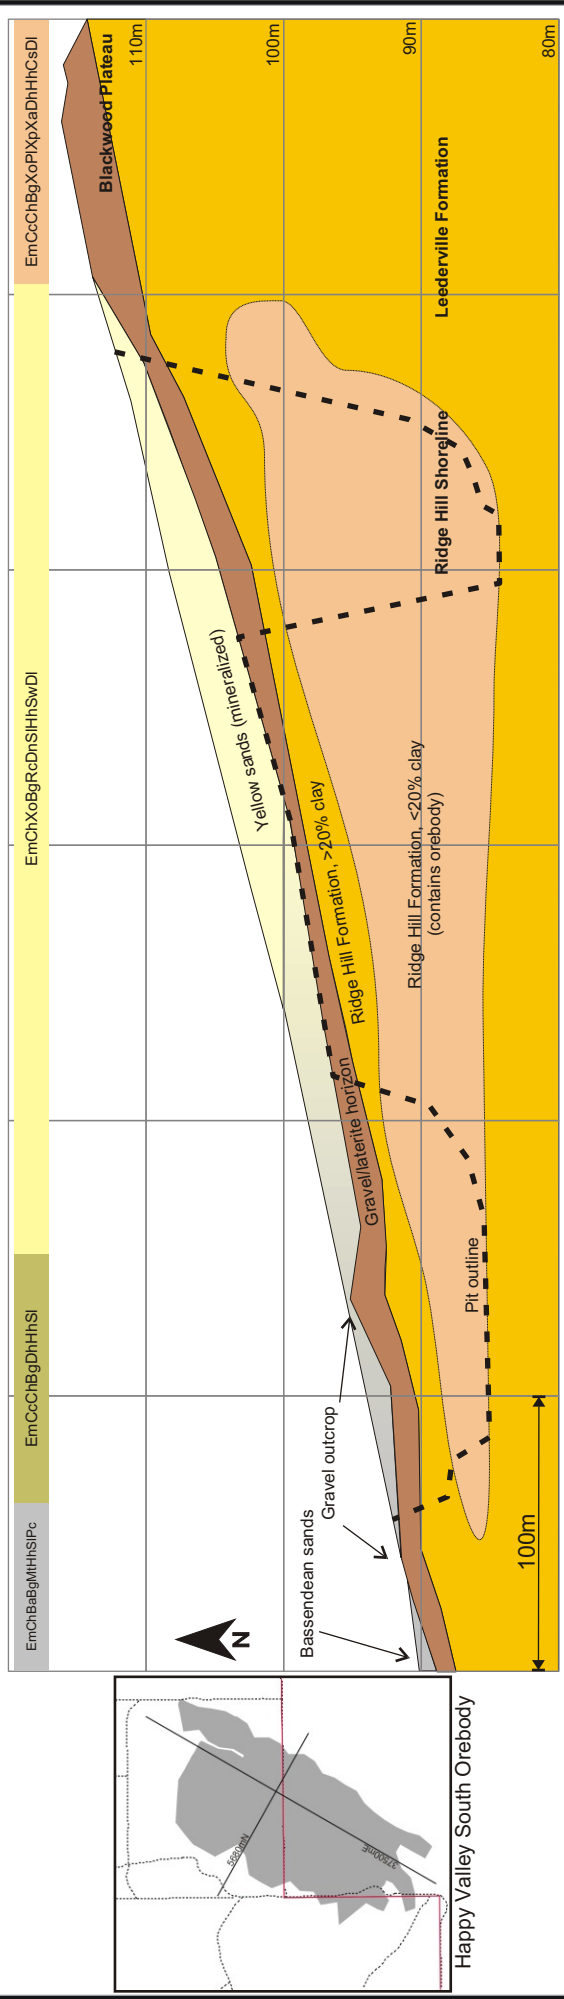
Happy Valley South 5680mN drill line (view north)
